HOUSE DAMAGE ASSESSMENT

URS Research Company

Defense Nuclear Agency

June 1972

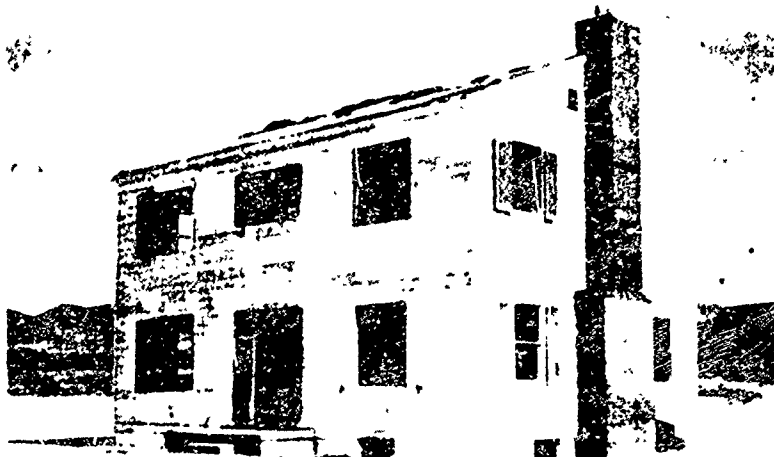
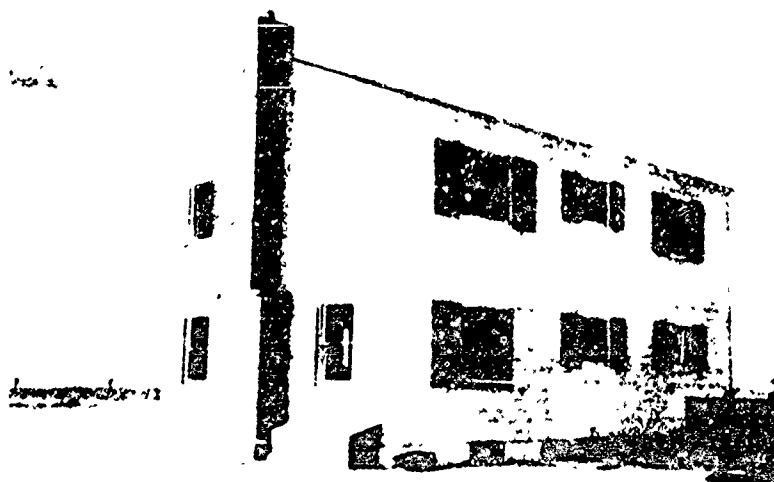
Fig. 2-1. Post-Test Photos, House I-1

This house was located at 7500 ft from ground zero where the incident peak overpressure was 1.7 psi. Post-test photographs of the exterior of the house are presented in Fig. 2-4. Doors, windows, and window frames were either blasted out of the walls or remained in place in a badly damaged condition. In general, the window glass was shattered into small particles and scattered uniformly about the exterior of the house. The only windows

remaining intact were four windows at the rear of the house which were sheltered by interior partitions, and the rear basement windows, which were blown open inwardly. The majority of the 2- by 8-in. floor joists of the front floor system were undamaged. Exceptions were a broken joist under the kitchen, three broken joists under the dining room, and the damage under the living room as shown in Fig. 2-5.

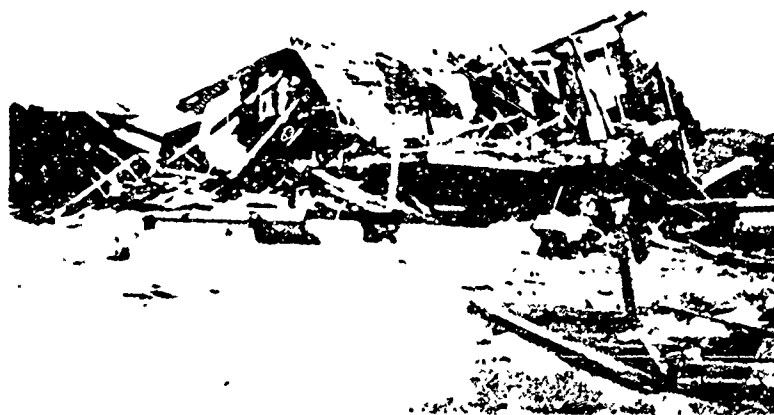
Fig. 2-12. Front of House I-2

This house was located at 3500 ft from ground zero where the incident peak overpressure was 5 psi. Figures 2-12, 2-13, and 2-14 show the front, side, and rear of the house after the blast. The house was demolished beyond repair. Figure 2-15 shows the large area over which debris was scattered. The front half of the roof broke in the middle at approximately the mid-span of the rafters, with the lower part lifting at the eaves, pivoting about the breaks and sailing through the air, then landing on the ground at the rear of the house. See Figs. 2-16 through 2-19 for enlargements of motion picture frames taken of the test.

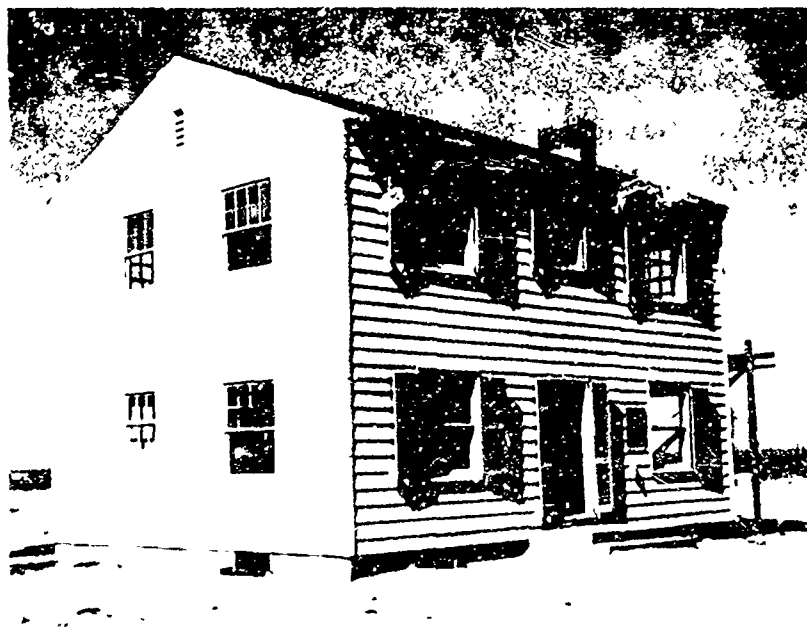
Fig. 2-27. Front and Right Side of House I-5

This house was located 865 ft from ground zero where the incident peak overpressure was 1.3 psi. After the blast, all the front windows except the small one above the front door were completely removed (see Fig. 2-27). Figure 2-28 is a view of the back and left side of the house. Note the window damage on the left wall, and the fact that only one pane of glass on the back wall was broken. Moderate chimney damage is indicated by the chalk marks in Fig. 2-29. Large quantities of glass, pieces of window frame, and window shades were scattered throughout the interior of the house (see Figs. 2-30 and 2-31). Some plaster cracking was visible in several of the rooms.

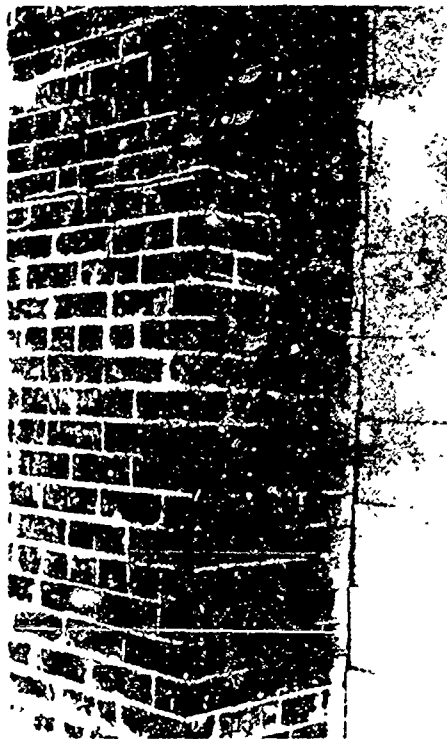
Fig. 2-29. Damage to Chimney, House I-5

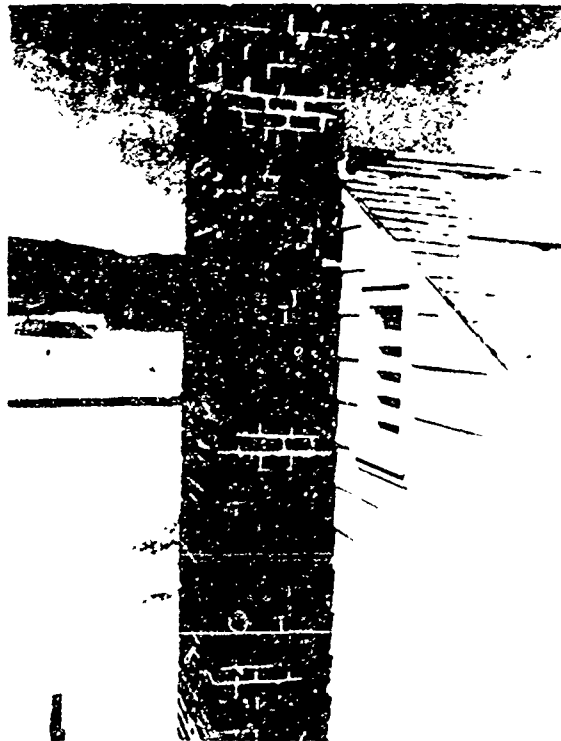
Fig. 2-34. Chimney Damage, House I-6

In Fig. 2-34, it may be seen that damage to the chimney was more severe after the second test than after the first. Cracks were larger and more spalling occurred; a large portion of the chimney was separated from the wall by an inch or more.

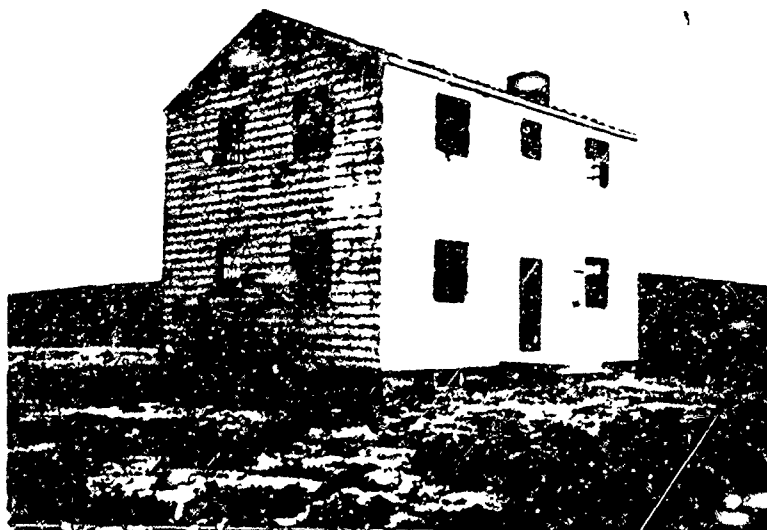
Fig. 2-39. Front and Left Side of House I-7

Post-test photos of the outside of this house are shown in Figs. 2-39 and 2-40. Other than extensive window damage in the front and sides of the house and removal of the front door, very little exterior damage was noted. There were only minor plaster cracks noted throughout the house, except for significant shear cracks on the sides near the windows. There was extensive

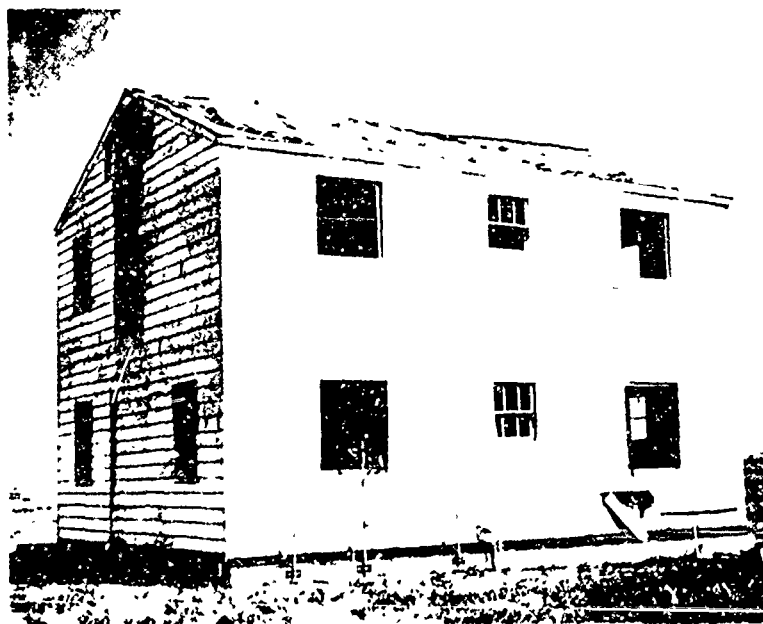
West Wall Considerable siding damage was observed under each window in the region of stud failure (see Fig. 2-60).

Fig. 2-60. House Exterior, North and West Sides of House I-9

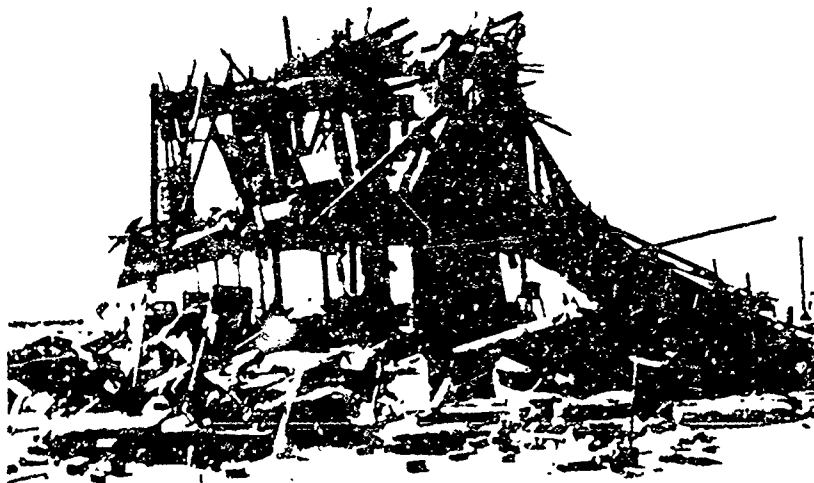
This house was located 4700 ft from ground zero where the incident peak overpressure was 5 psi. The aboveground portion of the house was demolished beyond repair (see Fig. 3-7). The exterior brick and cinder-block walls exploded outward into the yard around the house, with very little masonry debris falling on the floor framing. The chimney fell to the side of the house and lay on the ground broken into large sections. The roof was demolished and blown off; the rear side of the roof was lifted off and deposited on the ground on the far side of the house about 50 ft to the rear. Some of the bearing partitions, those around the staircase and first floor hall and those on the second floor, remained standing but were badly racked. The stair from first to second floor remained standing. The second floor partially collapsed on the first floor but on one side of the house about 50 percent of the ceiling joists remained hanging from the partition. Many of the joists did not split, and part of the second floor construction

Fig. 3-7. Post-Test Photo, House II-2 (front view)

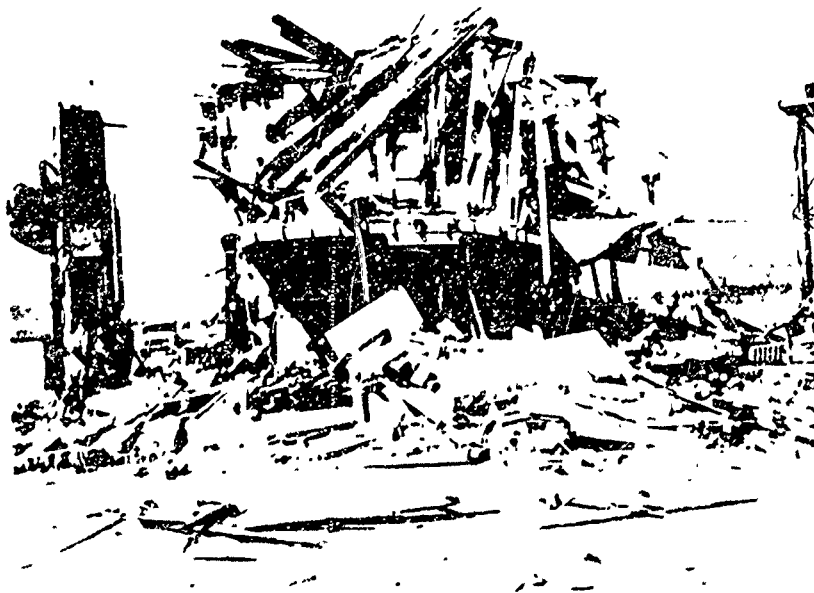
remained where supported by bearing partitions. Many of the second floor joists were not broken or split and acted as cantilevers from the bearing partitions (see Fig. 3-8).

Fig. 3-8. Post-Test Photo, House II-2 (back view)

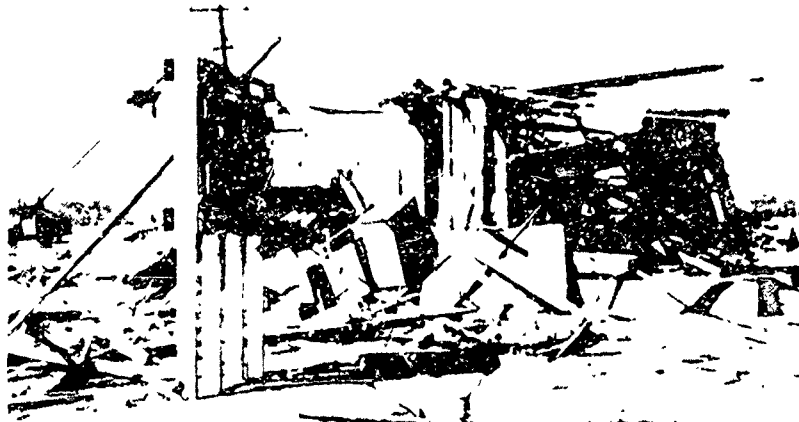
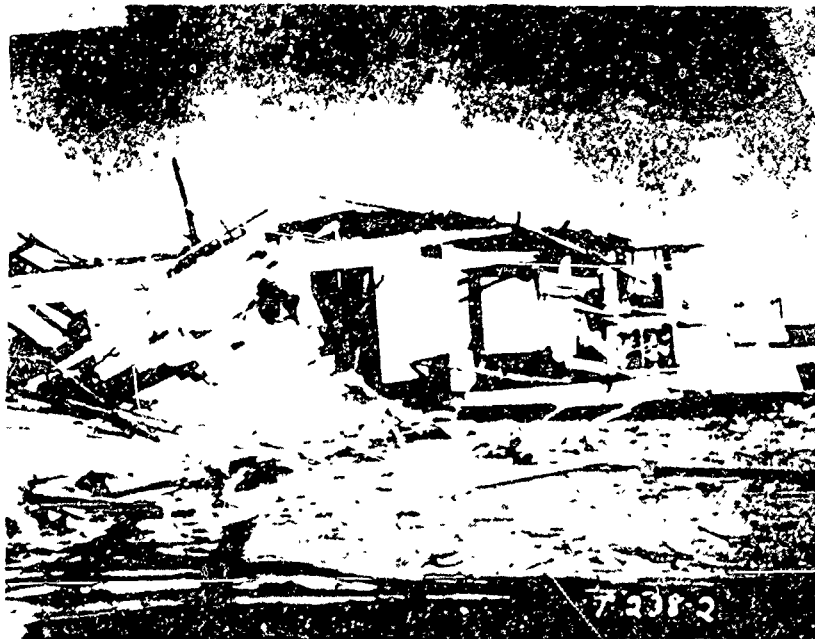
This house, located at 4700 ft from ground zero, experienced an incident peak overpressure of approximately 5.1 psi. The house was demolished beyond repair, with only the reinforced concrete bathroom shelter remaining intact (see Figs. 4-3 and 4-4). The roof was blown off; one section was found 100 ft to the rear of the house. All rafters were split and broken. The side walls at the gable ends were blown outward and landed approximately 75 ft to the rear of the house. A portion of the front wall was still standing, but leaning inward. The observation was made in the original reference that had it not been for the bathroom shelter, which served to give some measure of support to the house, the house would probably have been blown entirely from its slab foundation.

Fig. 1-3. Post-Test Photos, House III-1

Fig. 4-4. Post-Test Photos, House III-1

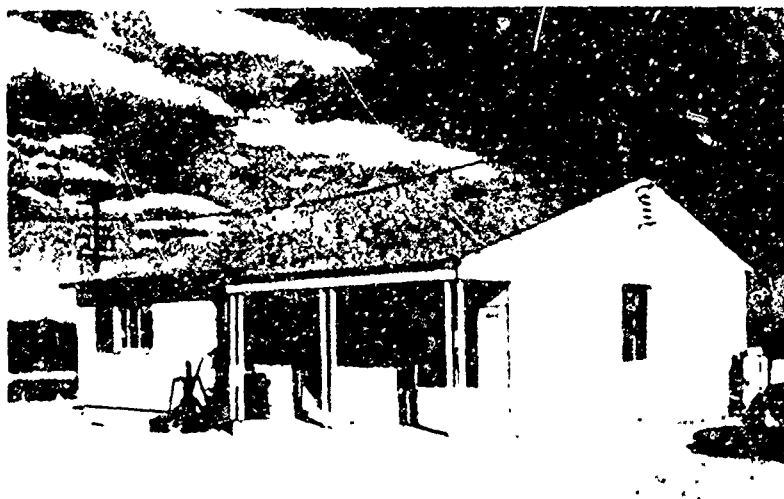
This house was located 10,500 ft from ground zero where measured overpressure was approximately 1.7 psi. This house suffered only minor structural damage (see Fig. 4-5). A 2- by 4-in. stud located between the front door and window was broken, as was a mid-span rafter support beam on the front side.

Fig. 1-5. Post-Test Photo, Front of House III-2

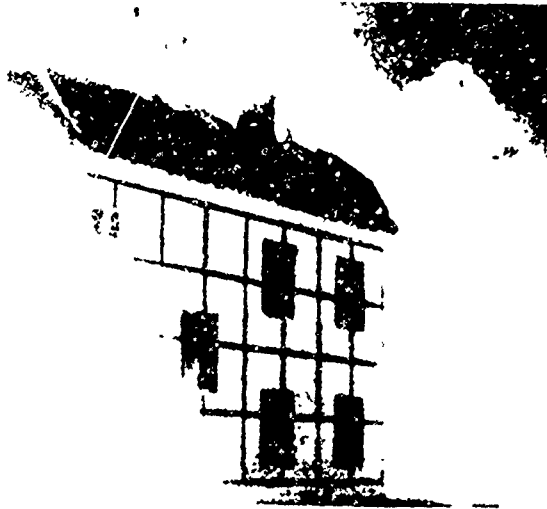
Fig. 5-1. Rear of House IV-1 Just After Arrival of Shock Wave

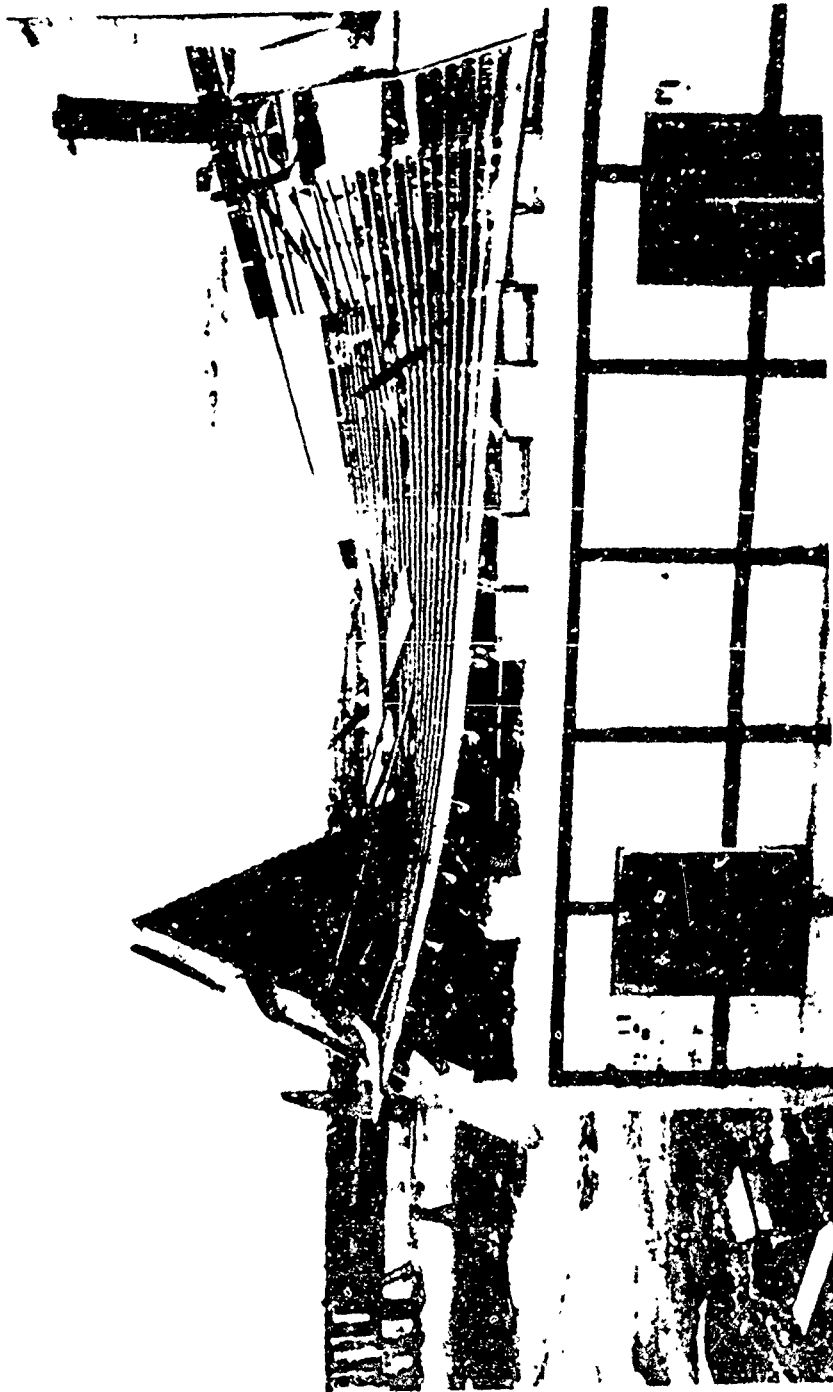
The central chimney broke off at the level of the attic floor and dropped in several sections on the ceiling over the stairwell. The left rear chimney was cracked through at the level of the roof, but, although it was slightly displaced, it did not fall. About 80 percent of the fill-in brickwork under the eaves was racked and displaced. The gable of the right wall was cracked through on a horizontal line about 3-1/2 ft down from the peak. Except for this, there was no visible damage to any of the brick walls. Figures 5-7, 5-8, and 5-9 are general views of house No. IV-1 in the post-test condition.

Fig. 5-7. Post-Test Photo, Right Side of House IV-1 (viewed from the rear)

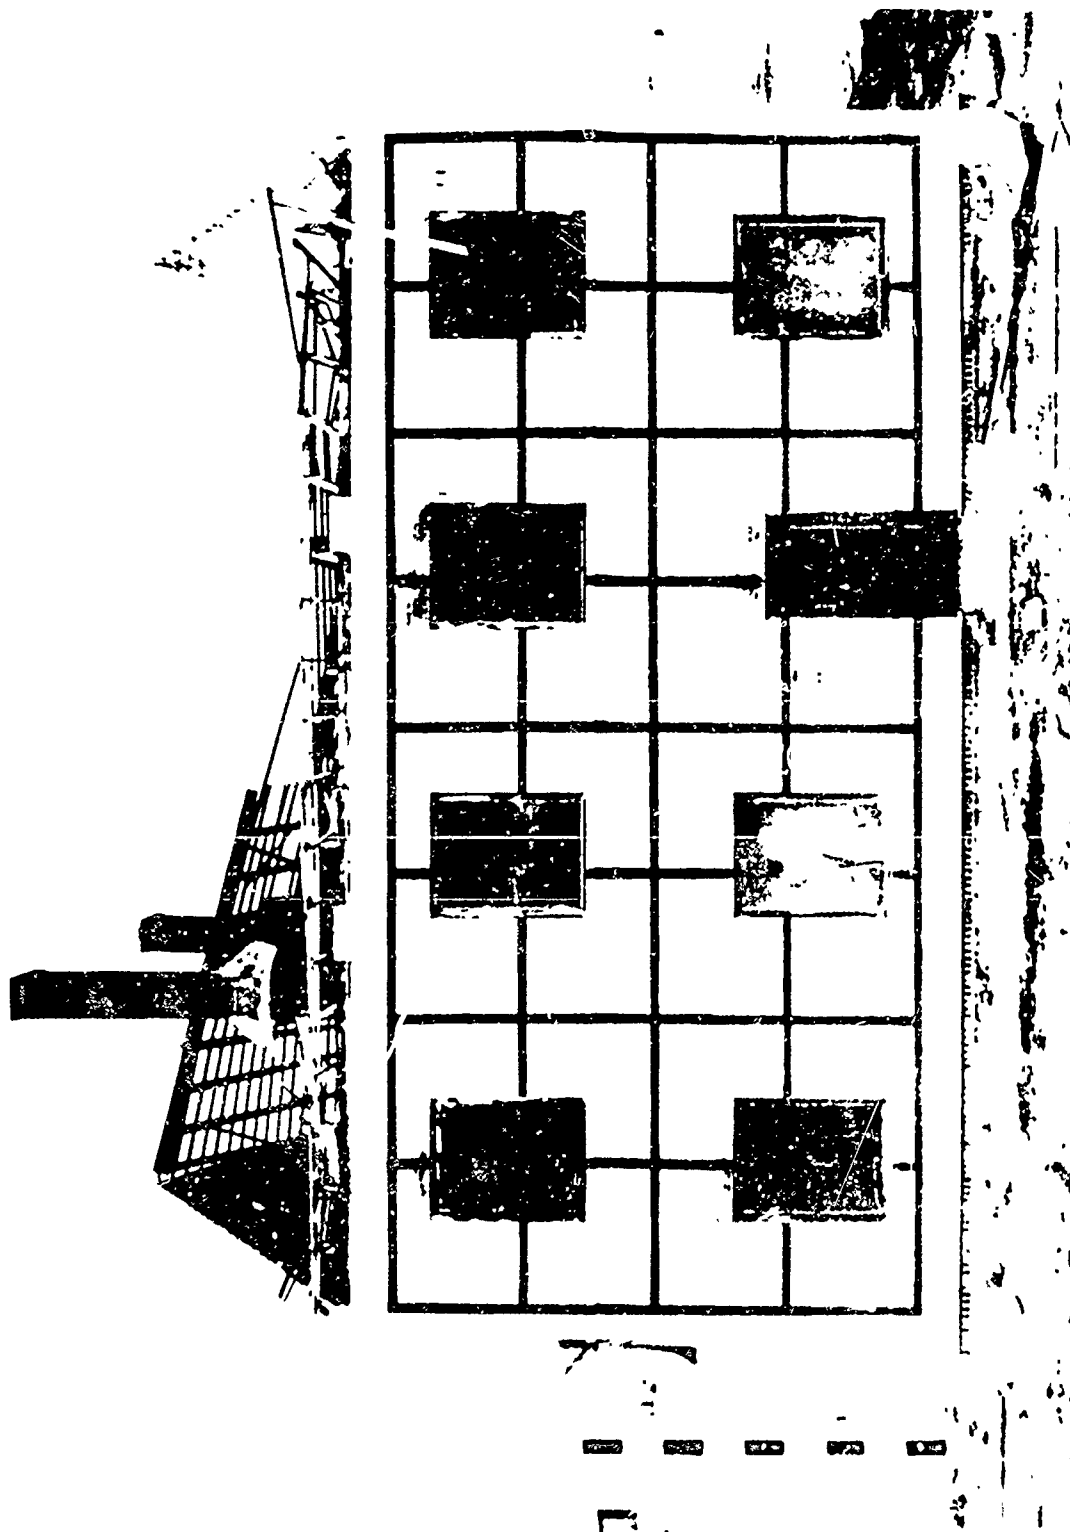
Fig. 5-8. Post-Test View, Rear of House IV-1

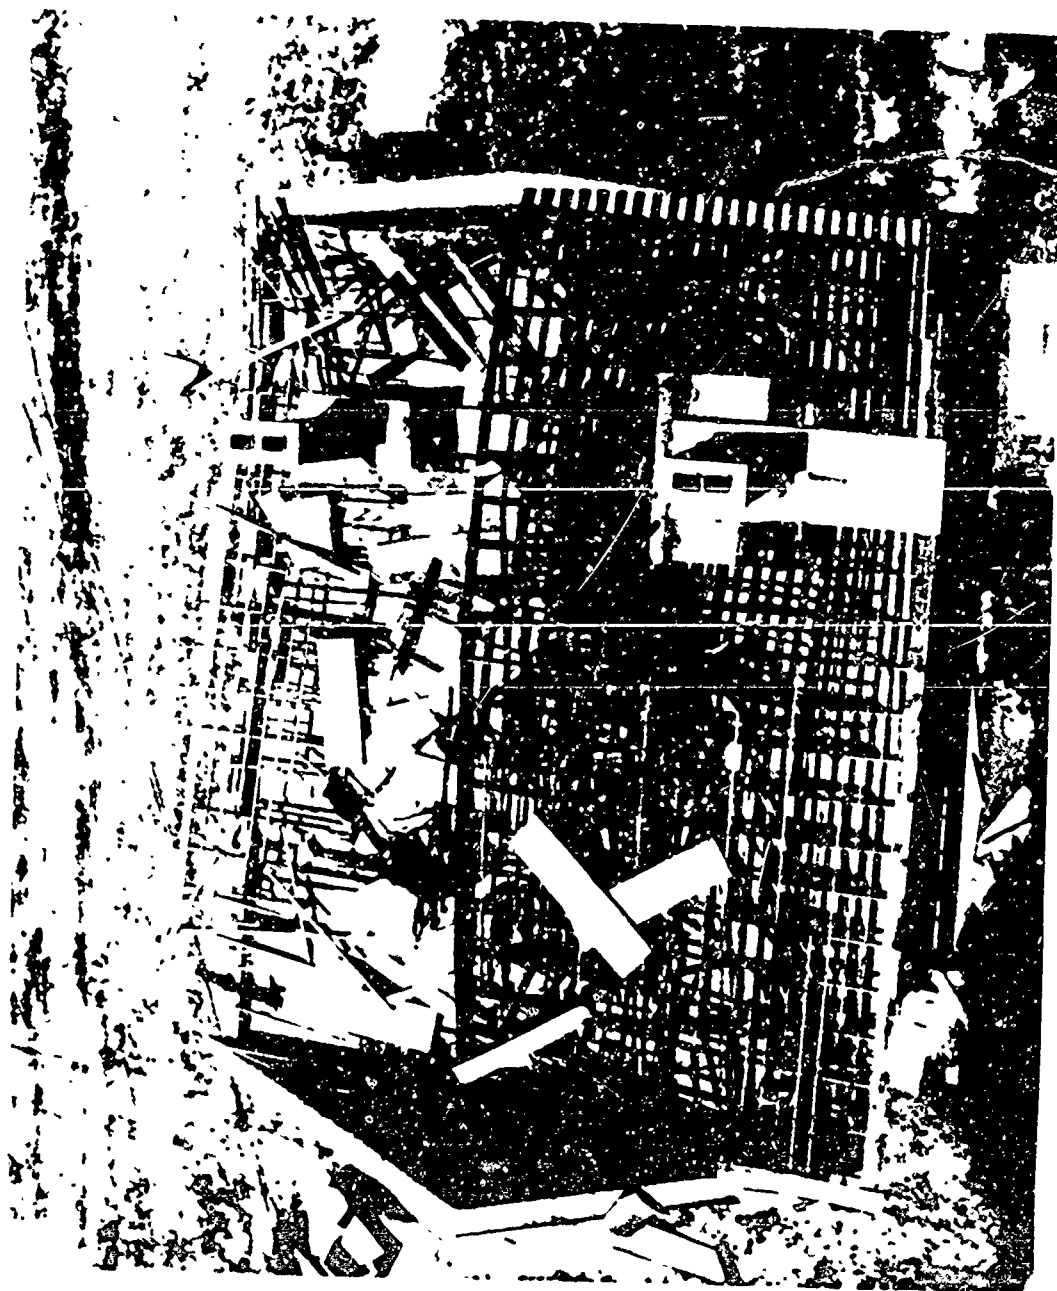
Fig. 5-9. Post-Test Aerial View, House IV-1

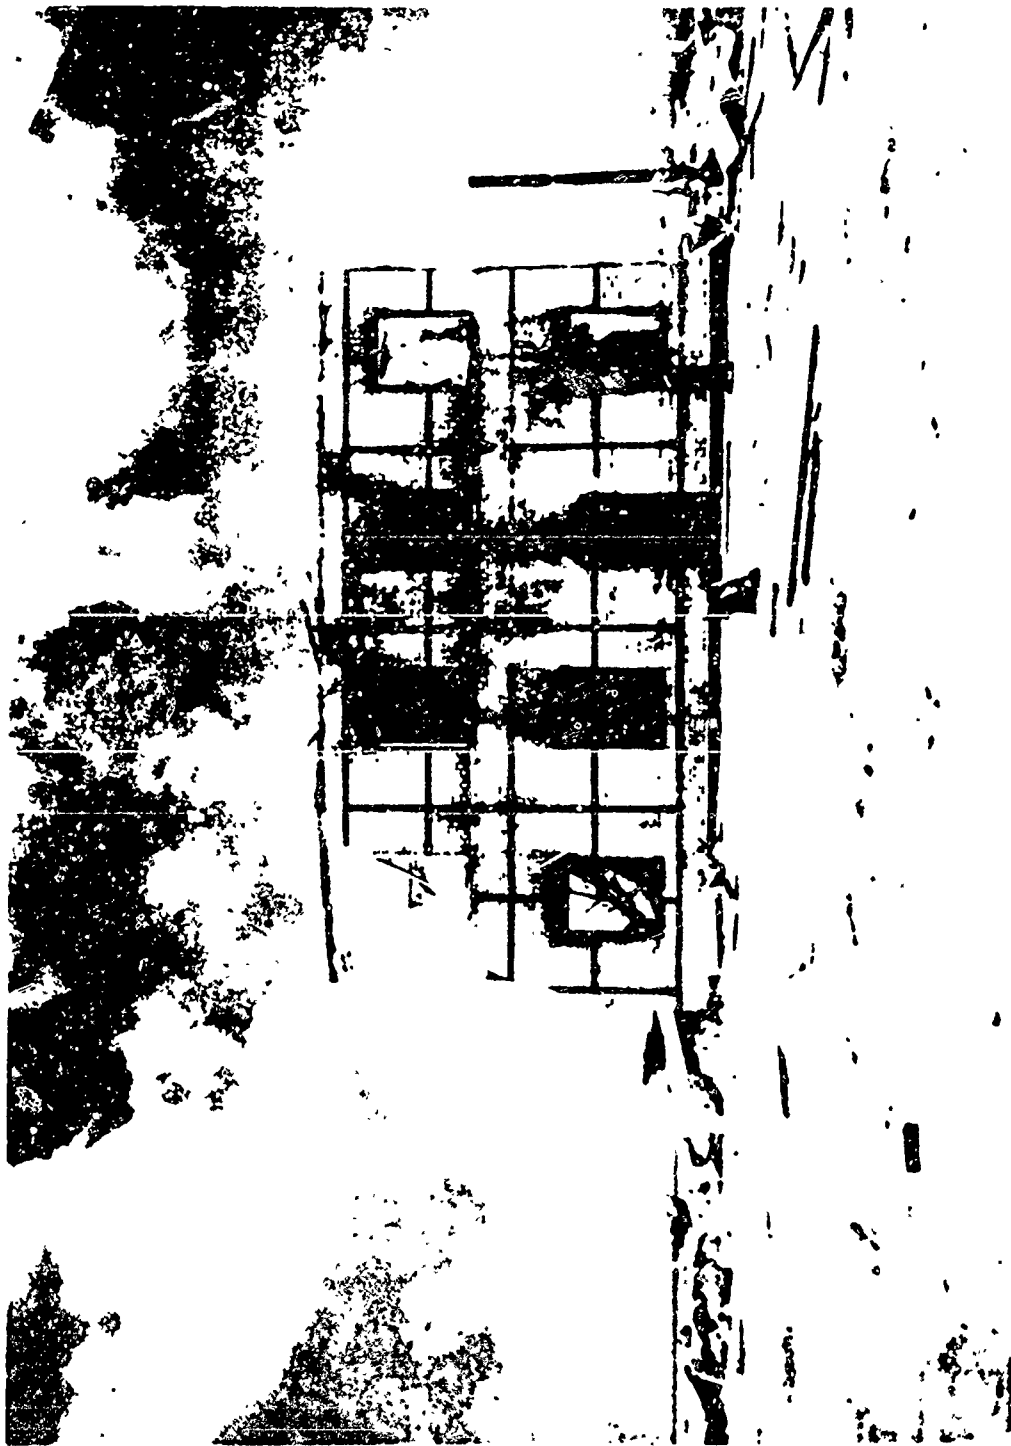
This house was located at 4245 ft from ground zero where the incident peak overpressure was 9 psi. Reference 7, from which this damage information was obtained, estimated the blast damage to be 40 percent.* Above the second story this structure was razed; the chimneys were toppled, and the roofing and roof rafters were carried away. Both brick gables fell vertically to positions beneath their original locations: the left wall was toppled as a unit to the side, and the forward 75 percent of the right wall was blown out to the side in two sections separated along the line of the first floor ceiling. (Here, and throughout this section, right and left are defined with the observer's back to ground zero.) With the exception of one pane of glass which remained in the window above the stair landing, all glass in the building was blown in. Doors were blown off or were broken off beyond the rear stile. Figures 5-11 through 5-14 are photographs showing general aspects of the blast-damaged building.

Fig. 5-11. Post-Test, Front View of House IV-2

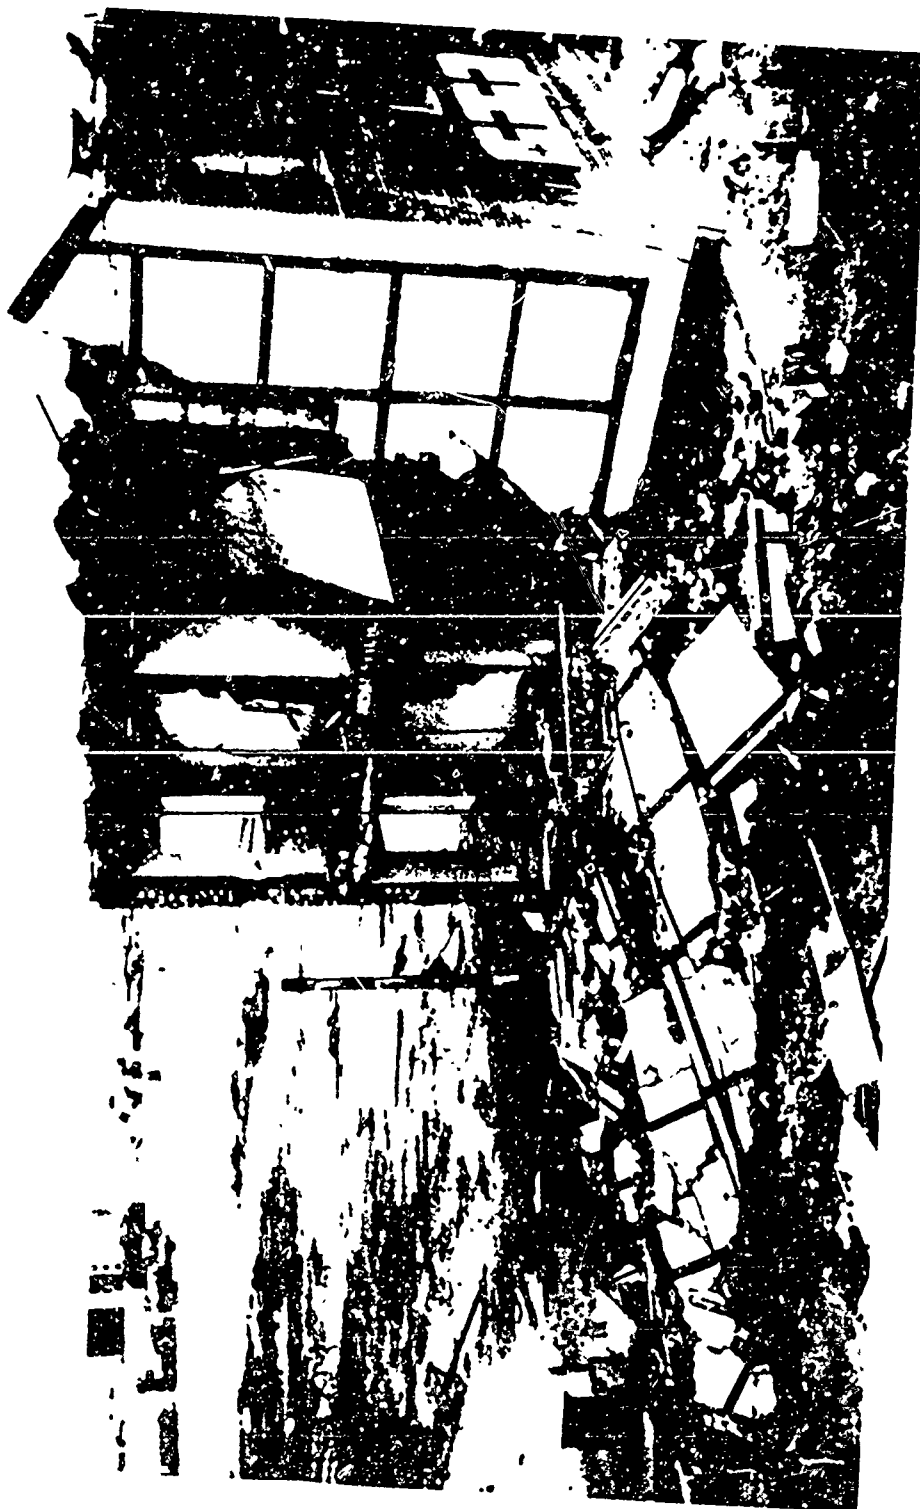
Fig. 5-12. Post-Test, Right Side of House IV-2

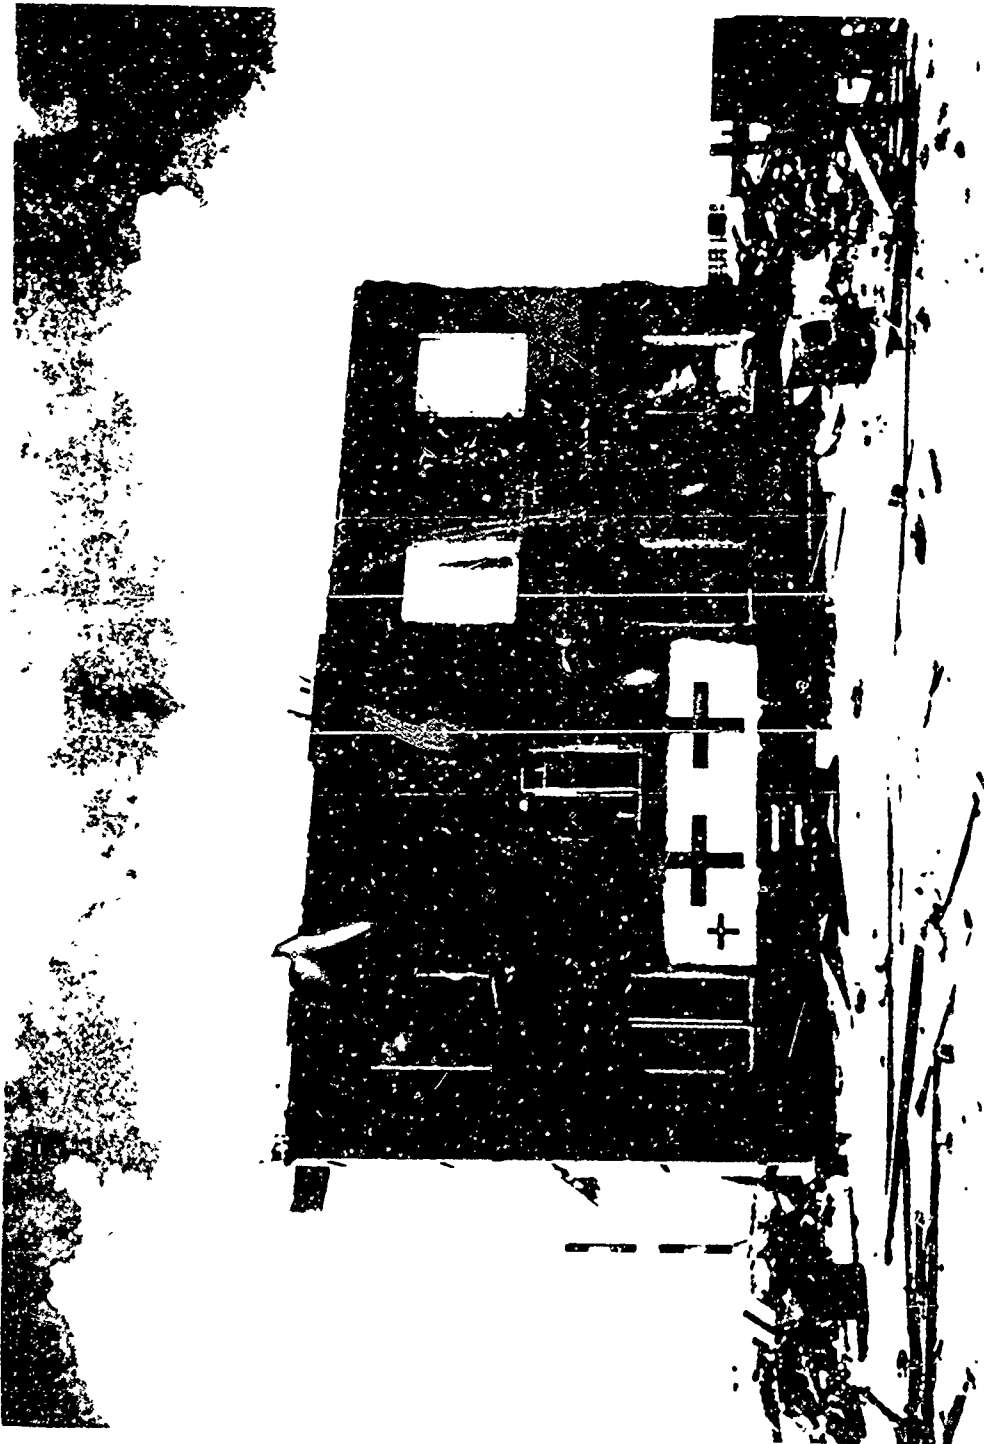
Fig. 5-13. Post-Test, Rear View of House IV-2

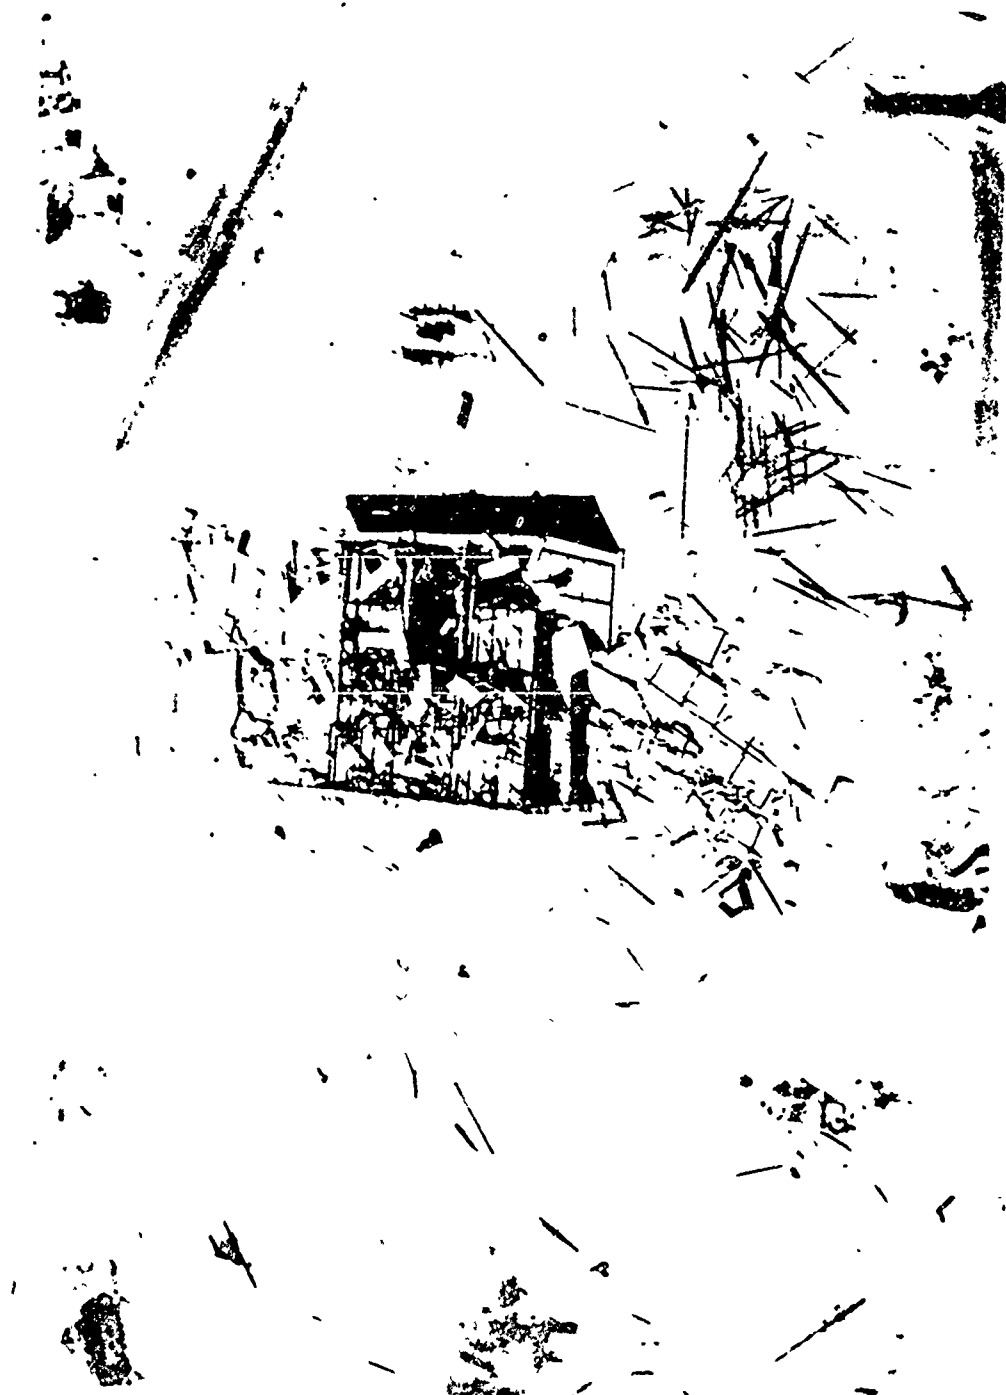
The roof debris is shown in Fig. 5-15. The distribution of this debris, metal roof, sheathing, stringers, and rafters was heaviest in the right rear quadrant, within 75 yd to the right of the building and 75 yd to the rear. A concentrated piling of the roof rafters was located 6 yd to the right and 19 yd to the rear of this corner of the building. About 15 of the roof sheets, several splintered rafters, and portions of the chimney framing were scattered over an area to the right of the building center line and within 100 yd ahead of the forward wall.

Fig. 5-15. Post-Test, Aerial View of House IV-2

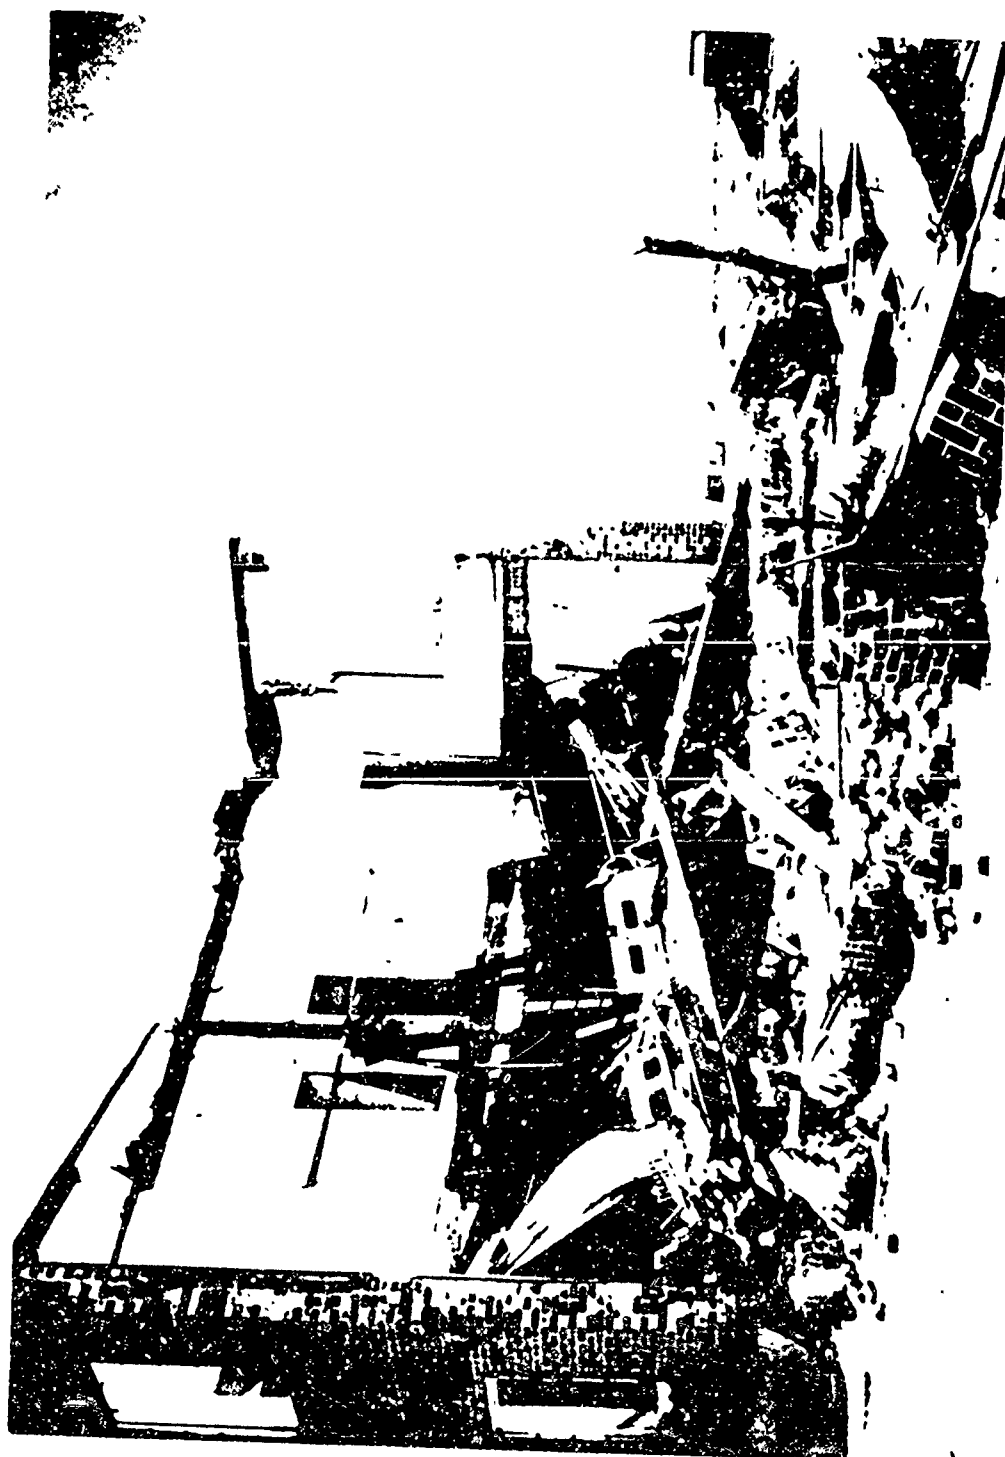
The asymmetrical section on the far left side of the building was almost completely collapsed, as can be seen in Fig. 5-18. In this section, only the rear brick wall and 75 percent of the forward brickwork remained. Missing from this side of the forward wall were the sections above and to the left of the upper window. The vertical brickwork at the side of the window was carried to the side; the horizontal section above the window fell out to the front. The floor structure between the first and second levels in this section collapsed downward in bending along the front-to-rear line of its connection with the interior brick shear wall. Ceiling sections above the second level fell intact down on top of the rubble and suffered only plaster damage. The final orientation of these sections was bottom up; they were completely separated from their supports.

Fig. 5-18. Post-Test Photo, Left Side of House IV-2 (viewed from the rear)

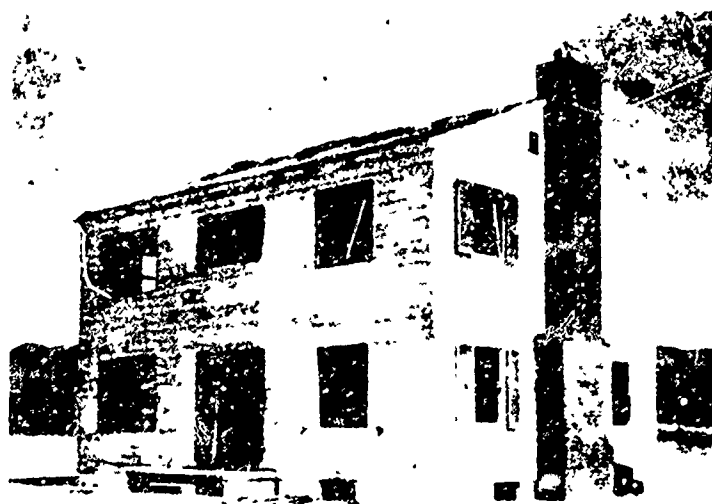
Fig. 6-1. House Damage Summary, House No. I-1

ITEM	DAMAGE PERCENT (each element)	CHANGE PERCENT (total value)
Floor and Ceiling Framing	12	2.0
Roof Framing and Roof Surface	35	2.5
Exterior and Interior Wall Framing	9	1.4
Interior Plaster	5	0.6
Exterior Sheathing and Siding	0	0
Doors	50	2.3
Windows	88	4.2
Foundation and Basement	0	0
Misc.: Stairs, Fireplace Paint, Trim	6	0.7
TOTAL		13.7

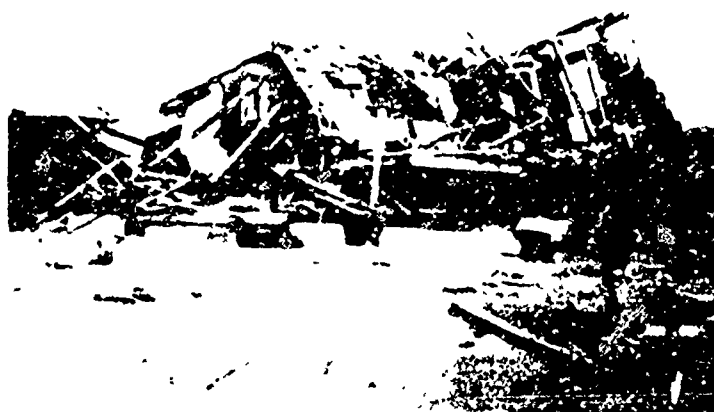
Fig. 6-2. House Damage Summary, House No. 1-2

ITEM	DAMAGE PERCENT (each element)	CHANGE PERCENT (total value)
Floor and Ceiling Framing	100	17.0
Roof Framing and Roof Surface	100	7.0
Exterior and Interior Wall Framing	100	16.0
Interior Plaster	100	11.0
Exterior Sheathing and Siding	100	8.6
Doors	100	4.6
Windows	100	4.8
Foundation and Basement	3	0.6
Misc.: Stairs, Fireplace, Paint, Trim	100	<u>12.0</u>
TOTAL		81.6

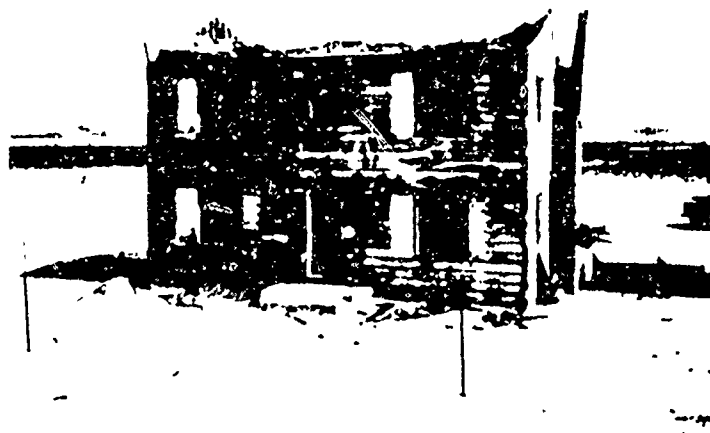
Fig. 6-3. House Damage Summary, House No. T-3

ITEM	DAMAGE PERCENT (each element)	CHANGE PERCENT (total value)
Floor and Ceiling Framing	20	3.4
Roof Framing and Roof Surface	100	7.0
Exterior and Interior Wall Framing	8	1.3
Interior Plaster	30	3.3
Exterior Sheathing and Siding	25	2.2
Doors	100	4.6
Windows	100	4.8
Foundation and Basement	0	0
Misc.: Stairs, Fireplace Paint, Trim	75	<u>9.0</u>
TOTAL		35.6

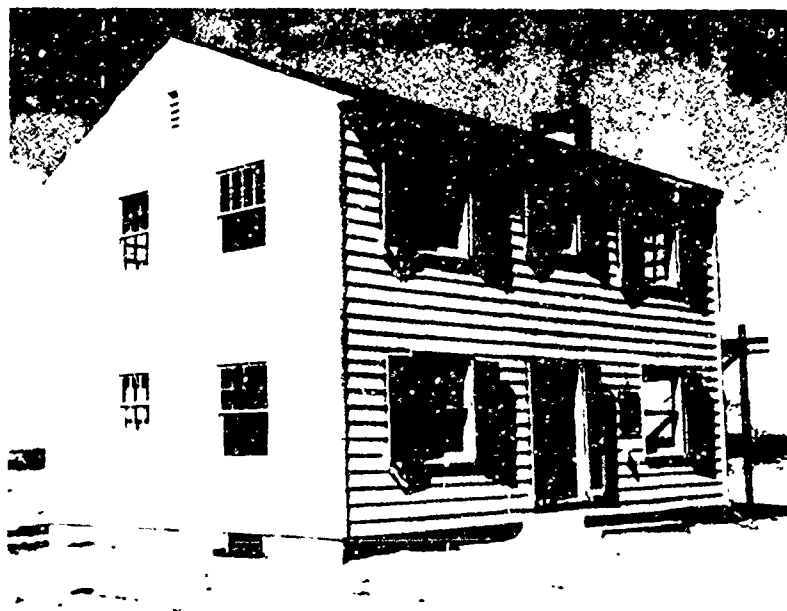
Fig. 6-5. House Damage Summary, House No. I-5

ITEM	DAMAGE PERCENT (each element)	CHANGE PERCENT (total value)
Floor and Ceiling Framing	0	0
Roof Framing and Roof Surface	1	0.1
Exterior and Interior Wall Framing	0	0
Interior Plaster	6	0.7
Exterior Sheathing and Siding	0	0
Doors	20	0.9
Windows	44	2.1
Foundation and Basement	0	0
Misc.: Stairs, Fireplace, Paint, Trim	12	1.4
TOTAL		5.2

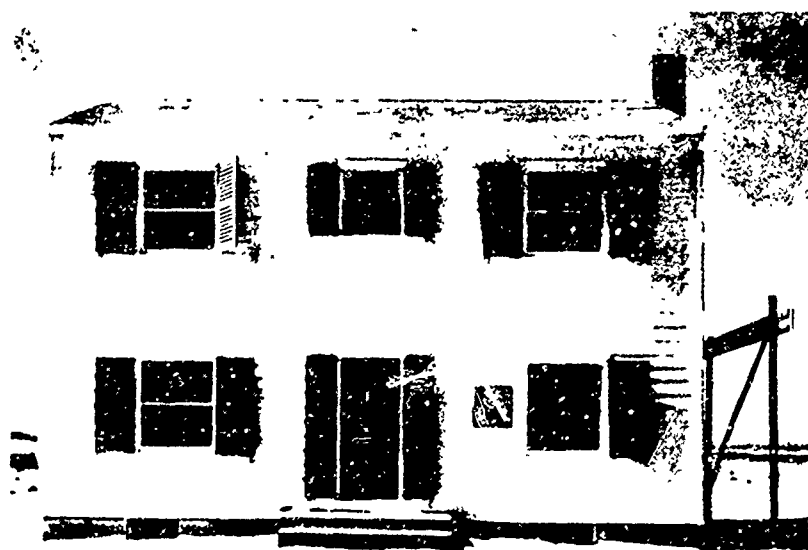
Fig. 6-6. House Damage Summary, House No. I-6

ITEM	DAMAGE PERCENT (each element)	CHANGE PERCENT (total value)
Floor and Ceiling Framing	0	0
Roof Framing and roof Surface	3	0.2
Exterior and Interior Wall Framing	0	0
Interior Plaster	6	0.7
Exterior Sheathing and Siding	0	0
Doors	20	0.9
Windows	61	2.9
Foundation and Basement	0	0
Misc.: Stairs, Fireplace, Paint, Trim	15	<u>1.8</u>
TOTAL		6.5

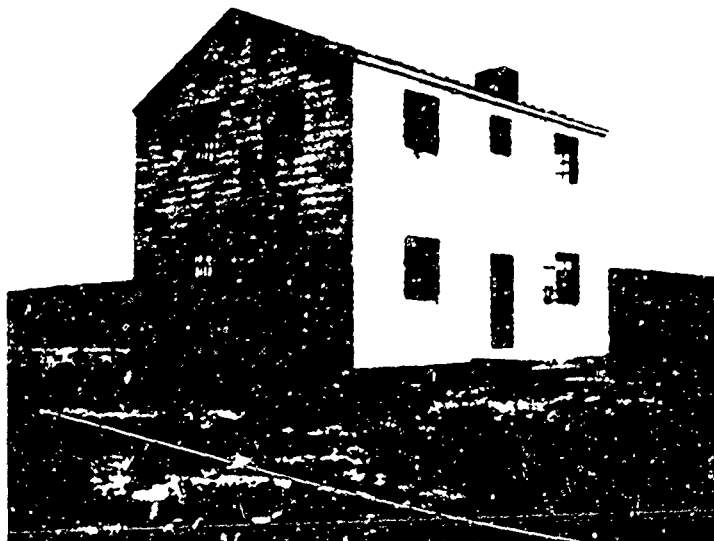
Fig. 6-7. House Damage Summary, House No. I-7

ITEM	DAMAGE PERCENT (each element)	CHANGE PERCENT (total value)
Floor and Ceiling Framing	0	0
Roof Framing and Roof Surface	14	1.0
Exterior and Interior Wall Framing	3	0.5
Interior Plaster	5	0.6
Exterior Sheathing and Siding	0	0
Doors	18	0.8
Windows	47	2.3
Foundation and Basement	0	0
Misc.: Stairs, Fireplace, Paint, Trim	3	0.4
TOTAL		5.6

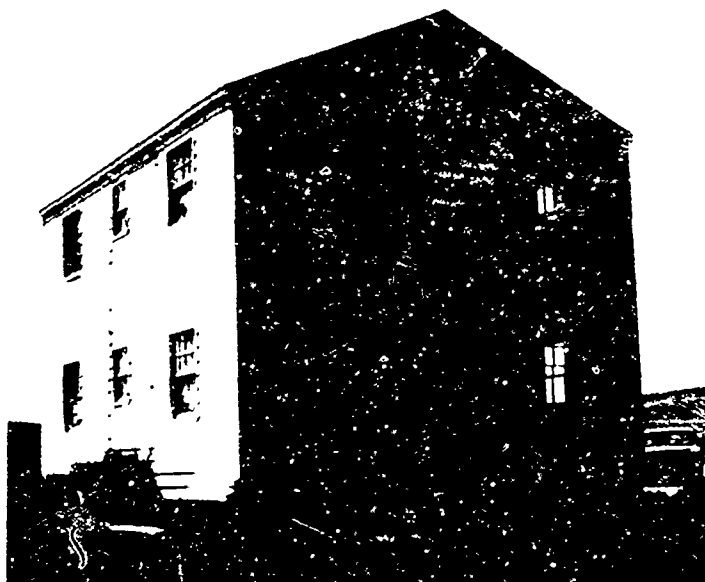
Fig. 6-8. House Damage Summary, House No. I-8

ITEM	DAMAGE PERCENT (each element)	CHANGE PERCENT (total value)
Floor and Ceiling Framing	0	0
Roof Framing and Roof Surface	27	1.9
Exterior and Interior Wall Framing	7	1.1
Interior Plaster	25	2.8
Exterior Sheathing and Siding	2	0.2
Doors	17	0.8
Windows	55	2.6
Foundation and Basement	0	0
Misc.: Stairs, Fireplace, Paint, Trim	12	<u>1.4</u>
TOTAL		10.8
